2018AF1367

Type -Examination Report of Special Equipment
LIFT

Product category	Lift safety protection device
Equipment Type	Unintended Car Movement Protection Braking subsystem
Product name	Traction machine brake
Model/Type	BLB
Manufacturer	SHENYANG BLUELIGHT DRIVE TECHNOLOGY CO.,LTD
Applicant	SHENYANG BLUELIGHT DRIVE TECHNOLOGY CO.,LTD

TYPE-EXAMINATION REPORT of
SPECIAL EQUIPMENT
(LIFT)

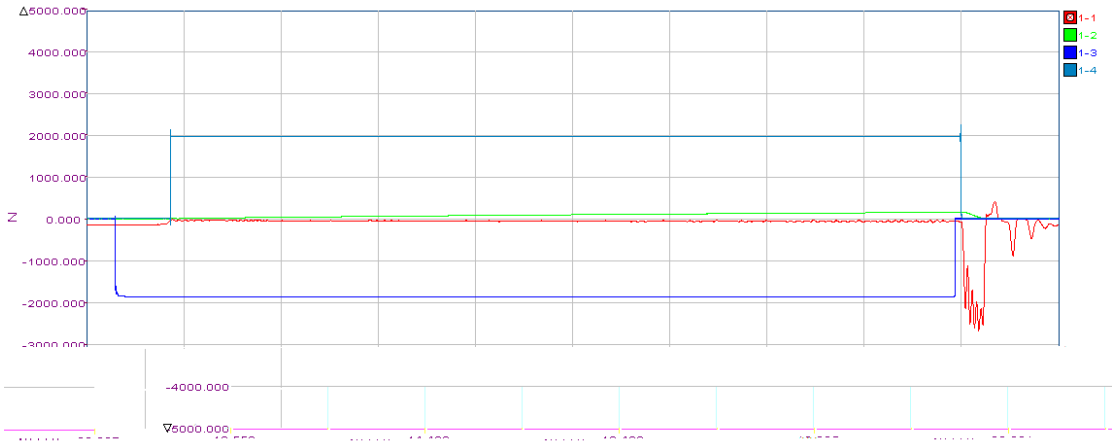
Full load car downward				
Item
